Cold Mix Evaluation | Updated July 2009

Virginia Department of Transportation, Materials Division – Asphalt Program

Evaluation of Vialit Asphalt's Rephalt Cold Mix Patching Material (also known as Aquaphalt)

Report Origin: Todd M. Rorrer, Assistant Asphalt Program Manager

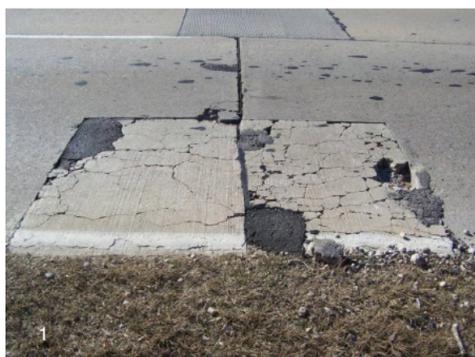
A deteriorated patch on US 60 West in New Kent County at Bottoms Bridge was selected for the evaluation site. This site would typically be repaired with hot mix asphalt (HMA), however the site was rapidly deteriorating and no HMA facilities were operational, therefore a 'permanent' cold patch solution was required.

Figure 1, Evaluation site on US Route 60 West at Bottoms Bridge.

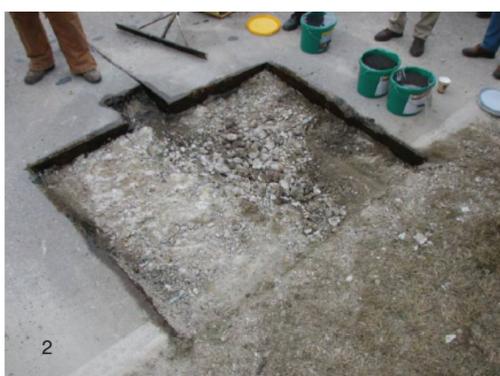
Figure 2

The existing distressed material was removed down to sound concrete. The leading half of the patch was found to be sound at a depth of approximately 5 to 6 inches (127 to 152.4 mm). The trailing half of the patch was deteriorated down to the subgrade in the center of the patch. The excavated patch was cleaned and blown free of loose debris, the deepest distressed portion was seated with a vibratory plate compactor.

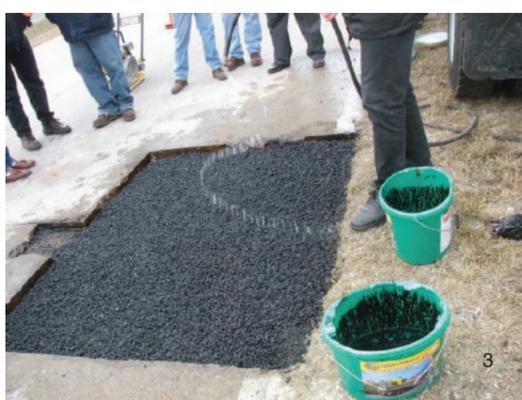
Figure 3

Two lifts 0/11mm mix were used as base and binder layers. The 'jumping jack' compactor was used for compaction on all layers lower than the final surface. Approximately 1 liter of water was added to each 25kg bucket before placement and an additional liter was "sprinkled" on the loose material before compaction.

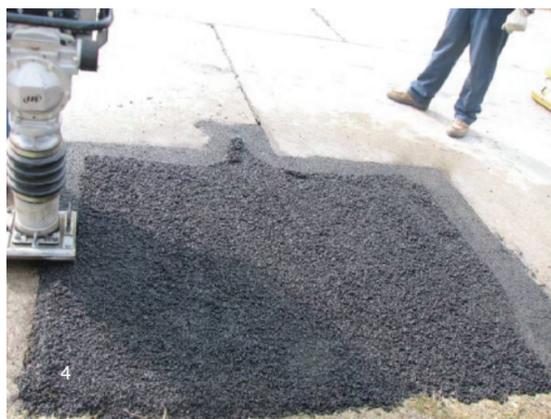
Figure 4

A final 0/8mm lift was placed for the final riding surface of the patch. Edges were pinched with the 'jumping jack' compactor.

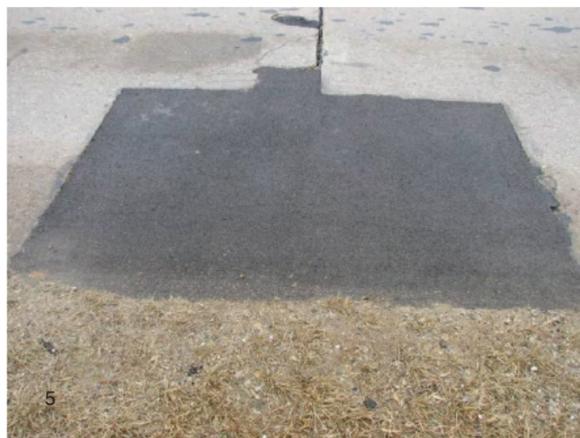
Figure 5, Evaluation site after one week of service.

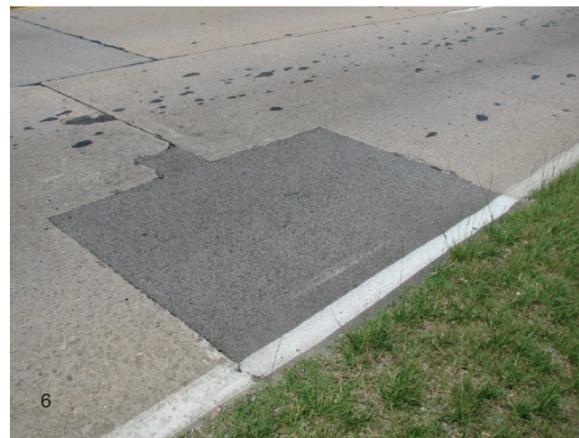
Figure 6, Evaluation site as of 06/26/08.

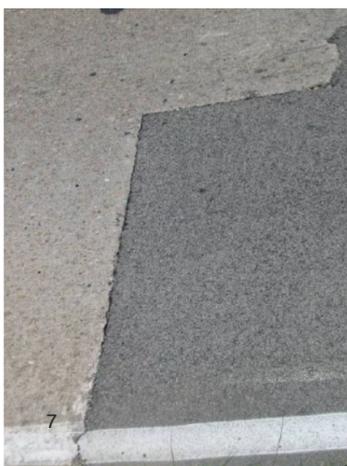
Figure 7

Material has maintained a uniform profile, very little to no pushing or shoving and no rutting.

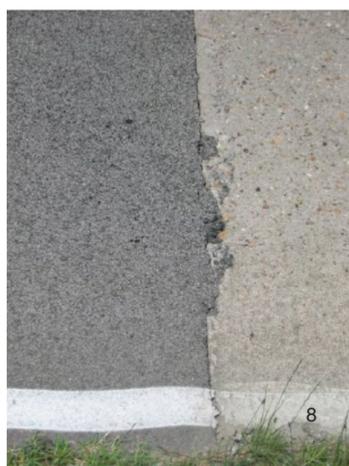
Figure 8

Tight joints have been maintained, material has not bled, or streaked away from the patch.

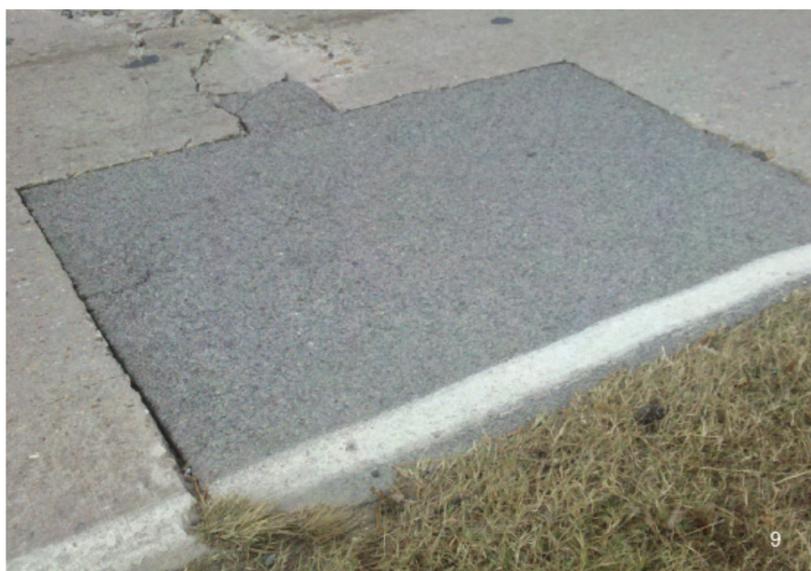
Figure 9, Four year follow-up photo, January 2012
