# AQUAPHALT®

Aquaphalt Testimonial | October 2015 | Norfolk, Virginia  
Virginia Paving Company, Division of The Lane Construction Company

## Evaluation of Aquaphalt in the Monitor-Merrimac Memorial Bridge-Tunnel

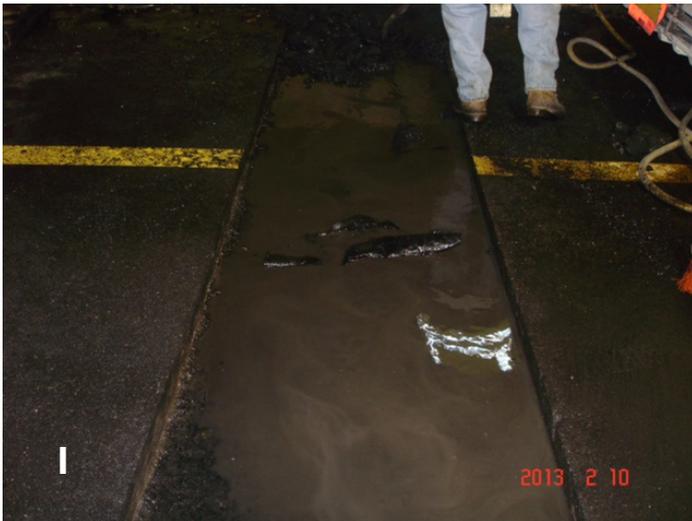
**Figure 1: Water Seeping In**

This shows an example of what we were dealing with, at the throat of the tunnel we were at 27' below sea level with sea water seeping in around a lot of these joints. As we removed the asphalt to repair the joint water was constantly seeping in. We would attempt to seal the joint the best we could with an injection sealant process then fill the patch with Aquaphalt.

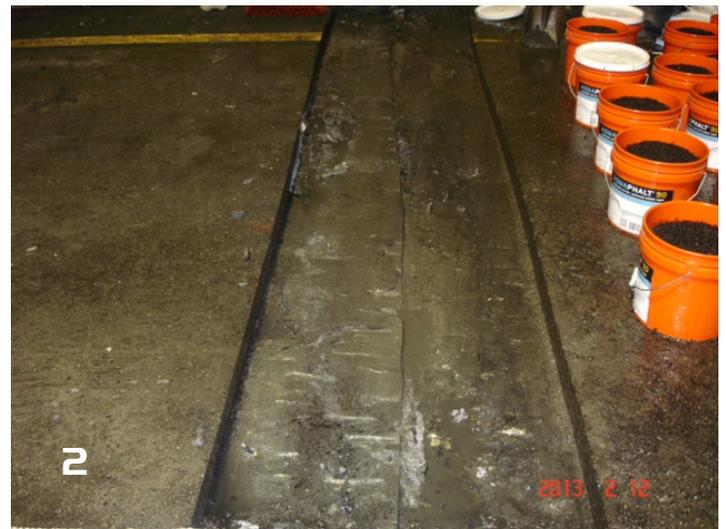
**Figure 2: Prepped Area Ready to Lay Aquaphalt**

Leaking joint stopped the best we could, but as you can see less than ideal conditions for asphalt with wet dirty conditions. In a lot of cases there was still standing water in these areas. I was skeptical at first whether the Aquaphalt would stay in these patches but it stayed in and the more we did the more confidence I had with this product.

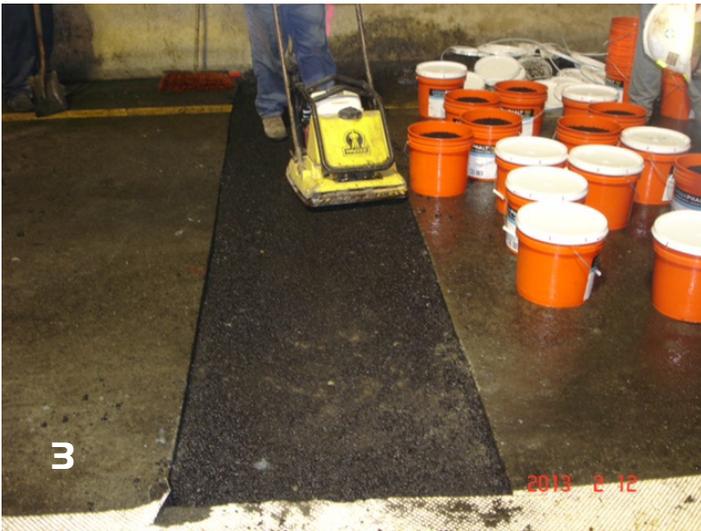
**Figure 3: The First Lift**

We placed the Aquaphalt in 2 lifts to make sure it didn't settle too much with the heavy traffic volume on Interstate 664. In one instance when we came in the next night, one of the patches did settle about  $\frac{3}{4}$ " so I tried putting a skim patch on top of what we did the night before doubting that it would adhere and stay in place. Not only did it stay in place there was water still seeping out of this patch. This was approximately 3 years ago and it is still in place.

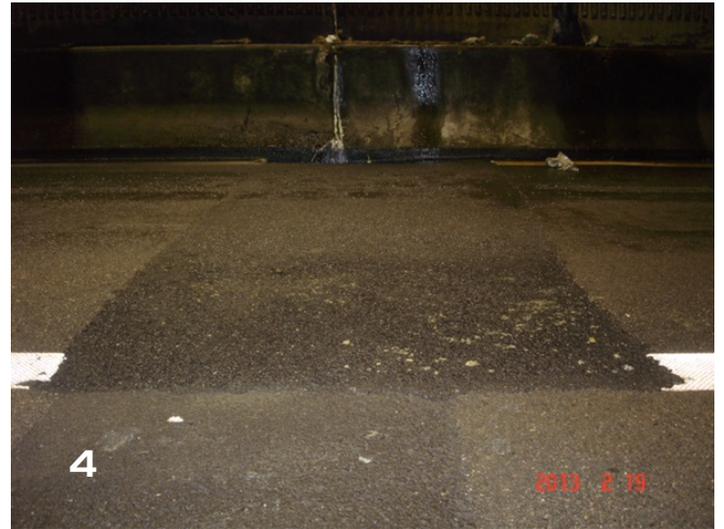
**Figure 4: Completed Patch**

Example of a finished patch, and as you can see there is still some sea water still seeping from the patch. Even with water still coming in the Aquaphalt remains in good shape after approximately 3 years.

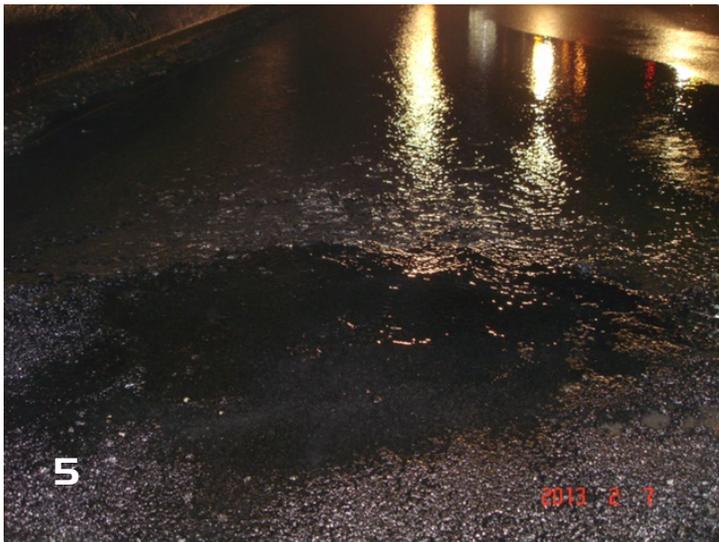
**Figure 5: Pothole in Lane**

This was a pothole that was approx. 10" deep, down to the concrete below. Massive amount of sea water running out of it right in the wheel path of the right lane. Filled it with Aquaphalt to safe up the lane until we did the joint repair in this location. Aquaphalt stayed in place until the repair was performed.
